# CASE STUDY

**Location:** Substation

**Issue:** Corona on capacitors bank cables

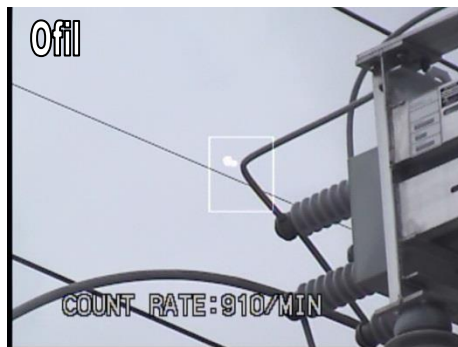
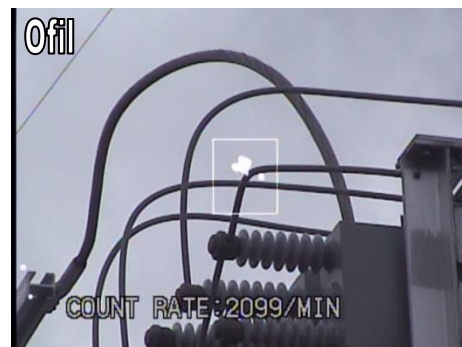
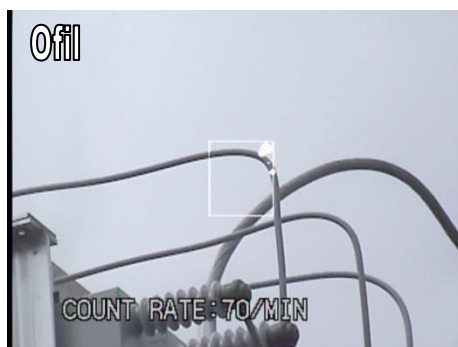
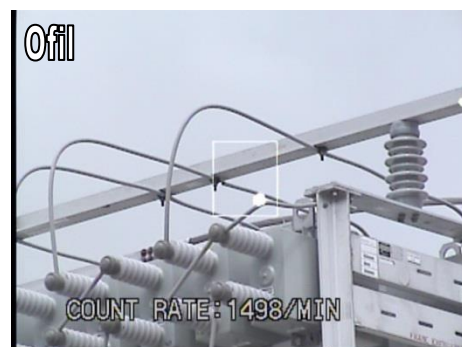
## Location of cracked cables on a capacitor bank

At this 500 kV substation, the utility experienced problems with the cabling to the capacitor bank. The cabling was redone and although it seemed to be satisfactory, the utility decided to inspect it for corona discharge. Many cases of cracked insulation showing corona were found. The cables were bent too sharply and the cracks then got even worse with the corona on them.
