CASE STUDY

Location: Distribution Substation

Issue: Intermittent problems on a 22kV line

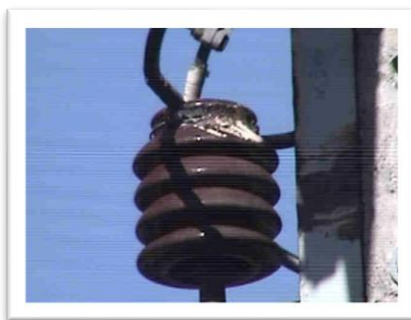
- When this line was constructed, the center phase standoff insulator was installed too close to the metal upright section of the pole.
- Either inclement weather or a bird has caused a flashover between the insulator and the pole, causing the line to trip out at the zone substation.
- Once power was restored, a visual inspection of the line failed to show up any defects.
- The line had tripped a few times since and then we were asked to inspect the feeder.
- We found no thermal faults; however, we found what appeared to be a very minor corona discharge on an insulator.
- On closer inspection, we found that this was the insulator that had been the cause of the intermittent outages.

- The left picture is the corona detected. The picture to the right is a close-up of the insulator using the zoom feature of the corona camera.
- The weather on this day was a clear fine day with low humidity and about 18 degrees Celsius. A day where **you would not expect to find any corona** on 22kv equipment.
