What Happens Before the Hotspot? UV and Thermal Imaging in High-Voltage Systems

Different Failure Mechanisms. Complementary Detection Technologies.

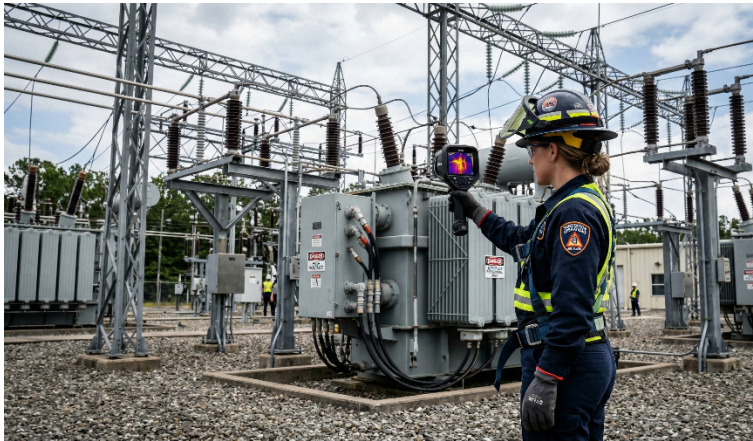
Substation inspection with a thermal camera

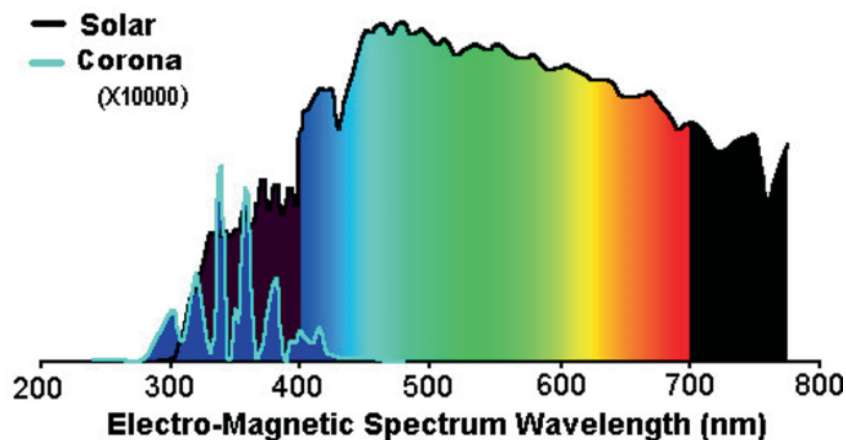
A spectral graph illustrates the distribution of corona emission and solar radiation across the ultraviolet spectrum, demonstrating why solar-blind filtering is required for reliable daytime inspection.

Corona partial discharge light emission occurs broadly within the UVA (315-400 nm), UVB (280-315 nm), and UVC (100-280 nm) regions. However, sunlight also contains significant ultraviolet radiation within the UVA and UVB bands. This overlap presents a challenge for daytime PD detection, since solar ultraviolet radiation can overwhelm or mask corona PD signals.

To enable reliable daylight inspection, solar-blind UV cameras operate within the UVC band. In this region of the spectrum, atmospheric ozone absorbs solar radiation before it reaches the Earth's surface. As a result, the background solar UV level in the UVC range is extremely low, allowing corona discharge to be detected with high contrast even under full daylight conditions.

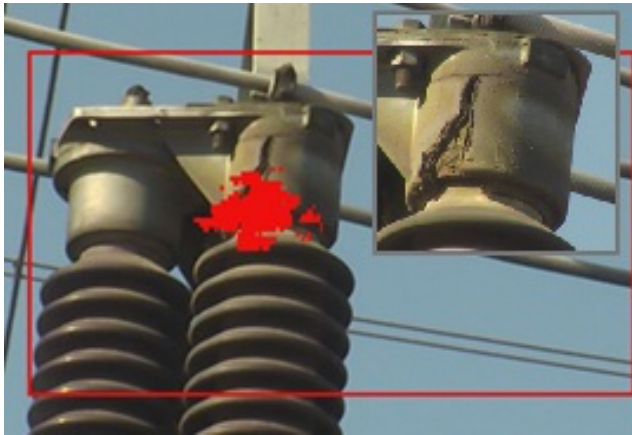
Corona discharge activity on HV insulator detected using a UV camera

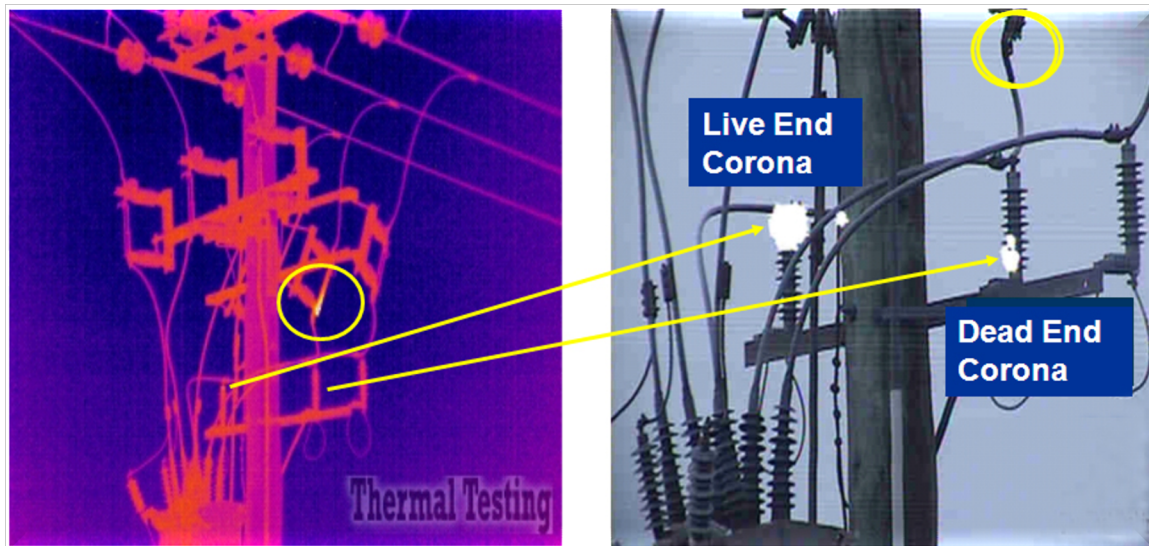
Multi-Spectral Inspection of a Distribution Pole Using UV and Thermal Cameras

The first discharge was located at the live end of the insulator. This type of activity can occur at energized hardware interfaces where electric field concentration is expected. While it indicates localized stress, it may represent a geometrically induced condition rather than immediate insulation failure.

The second discharge was observed at the dead end of the insulator. This location is more critical because it is intended to isolate the energized conductor from the pole structure. Corona activity at the dead end suggests that the insulator may not be fully insulating as designed. In such cases, leakage current or surface degradation could allow voltage to couple toward the pole hardware. Persistent discharge at this location warrants immediate evaluation, as it may indicate compromised insulation performance and a potential safety risk if the structure becomes unintentionally energized.

However, the thermal image revealed a separate hotspot at a compression connector (in circle). No ultraviolet discharge was observed at this connector location. The thermal anomaly suggests a resistive defect within the current-carrying path, likely caused by improper compression, mechanical loosening, or contact degradation.

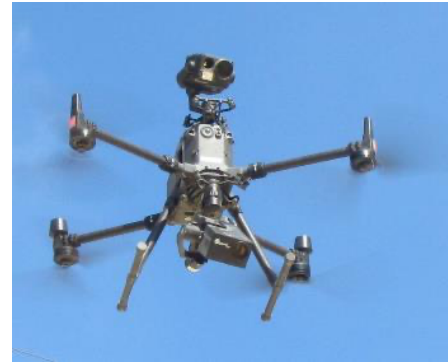
The image captured from the drone's remote controller shows two thermal hotspots on a high-voltage bushing, on the main display. On the lower right display, UV imaging reveals discharge activity at the same location, represented by red emission spots.

Simultaneous UV and IR Inspection on DJI M300

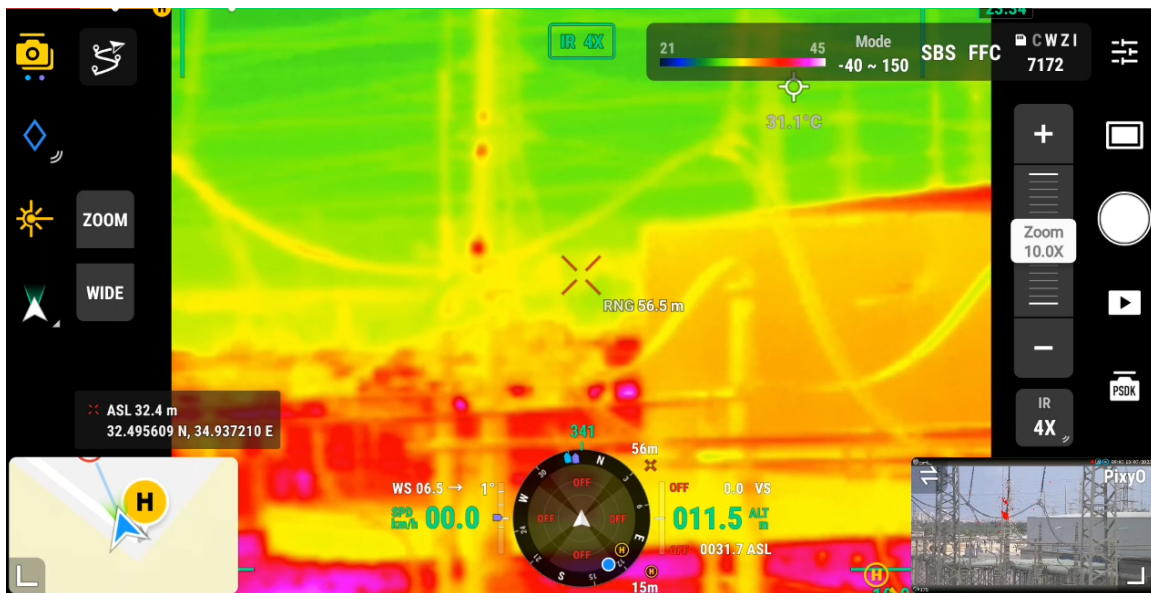
The thermal hotspots indicate localized temperature rise under load, suggesting resistive heating within or around the bushing assembly. The simultaneous presence of ultraviolet discharge at the same location confirms abnormal electric field behavior and active corona PD due to degradation of the insulation.

Hotspots and corona discharges detected on a high voltage bushing

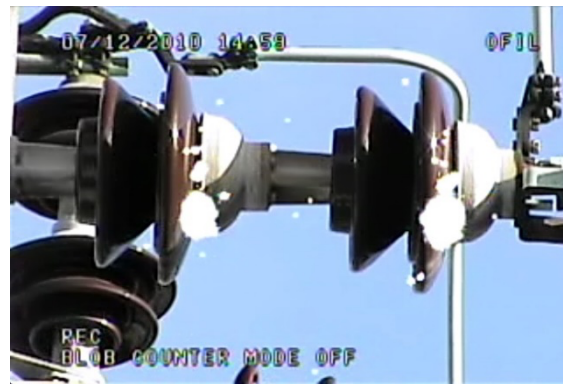
However, ultraviolet imaging identified discharge activity at two locations between the insulator disc and the metal cap. The discharge appeared concentrated at the interface region, suggesting localized electric field concentration.

UV image: two spots of corona discharge detected

Corona activity at the disc-to-cap interface may indicate the presence of a small air gap, improper seating during installation, cement degradation, or loss of internal bonding. Although no thermal anomaly was present, the discharge suggests compromised dielectric performance at that interface.
