Corona Camera Inspection

Abstract:

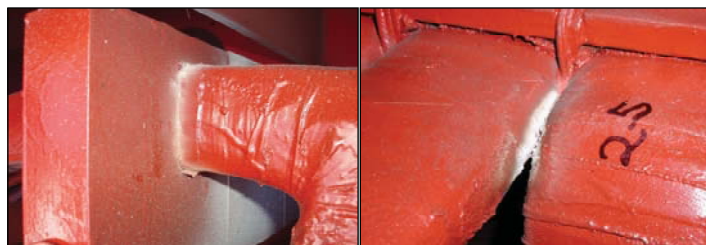
Mechanical dusting is generated when two components fret against one another (above left). Corona dusting can be generated within the stator slots, slot exits, end windings, and connections (above right).

Dusting is created by one of two different phenomena. Under the right circumstances, both can be working in consort with one and another within the same area. Mechanical dusting is generated when two components fret against one another. This activity leaves a deposit of fine particles. Left unchecked, this phenomenon could potentially abrade through critical insulated components leading to dielectric failure. Corona dusting can be generated within the stator slots, slot exits, end windings, and connections. Slot discharges occur when the coils become loose, causing the winding capacitive charging current to be dissipated to ground through concentrated contact points. This in turn generates localized areas that appear to glow, spark, and eventually burn. Left to continue, this phenomena will eventually compromise the ground wall insulation system and result in a winding failure to ground. Stress gradient materials, in particular those comprised of paints or varnishes, are susceptible to deterioration due to high thermal factors. Eventually, the interface between the stress gradient and the semi-conductive components is breached. This gap allows for the inception of discharging. Although this discharge activity can appear pronounced and wide spread, it is considered to be a rather

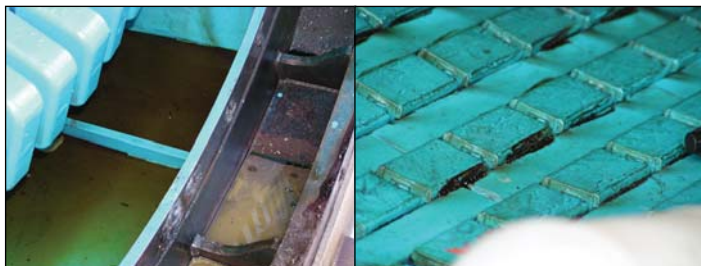
Subjected to oil (above left), wedges, side packing, and top ripple springs softened and loosen. In an oil-saturated environment, loose wedges will produce a greasy-type byproduct (above, right).

ins on post cure and shrinking of some of the wedging and packing materials allowing the coils to become loose. This is especially so for conventional wedging system. In windings fitted with top ripple springs and or side ripple springs, such chances of looseness are considerably minimized. While in the presence of oil, wedges, side packing and top ripple springs will tend to soften faster because of the lubricating medium.

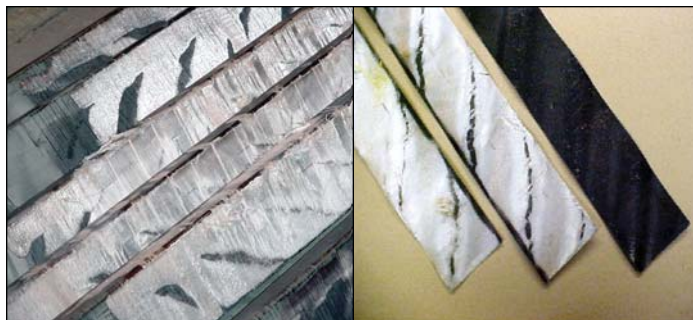
Ladder effect due to loose stator windings (above, left). The effects of mechanical and corona damage to side ripple springs (above, right).

If the coils are loose, the looseness will quickly allow the laminated rough stator core surface to damage the surface coatings on the coil. Damaged coil surfaces create discontinuities on the surface allowing voltage stresses to build up across these isolated locations, or, between these and the stator iron. If the voltage stress exceeds the electrical breakdown point of the air / gas medium, a discharge will occur. Eventually, a ladder effect develops where the groundwall is thinner at the point of contact with the core, but maintains normal thickness at the core air vents. Slot discharges accelerate the decomposition of the organic epoxy or polyester resin binders and the coils tend to decrease in size and may become further loose. Thus, machines with slight damage to the coil surfaces can still provide many years of reliable operation provided movement is stopped by a rewedge. Once damaged, it is difficult to restore the semi-conducting surfaces - so prevention is paramount.

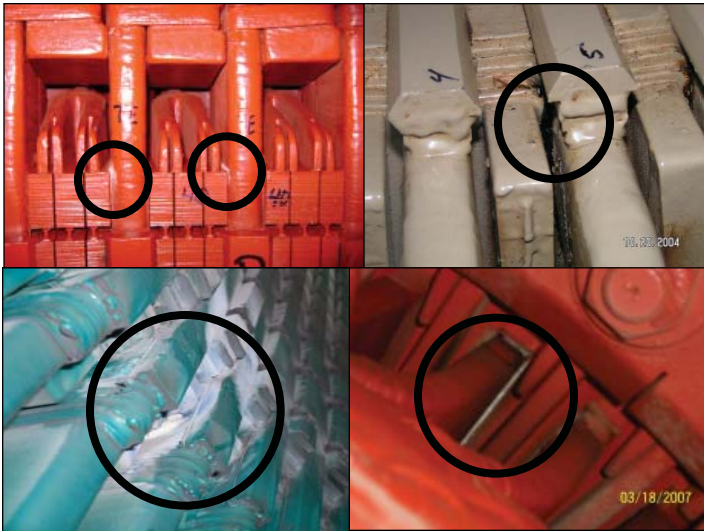
Windings with severely damaged surface coatings may require replacement because of the high production of ozone and accelerated erosion of ground wall insulation by slot discharges. The absolute time between detection of looseness and failure is kind of unpredictable, but it can be fairly short in hard thermoset windings, especially in those with a high electric stress across the groundwall. Air-cooled machines are much more prone to slot discharges. Based on visual observations on the winding and results of wedge tightness test, it may be determined if monitoring corona activity in a sample slot is required as input to the reliability assessment program in estimating condition of corona suppression system. Following pictures illustrate some typical cases of corona activity caused by looseness of winding:

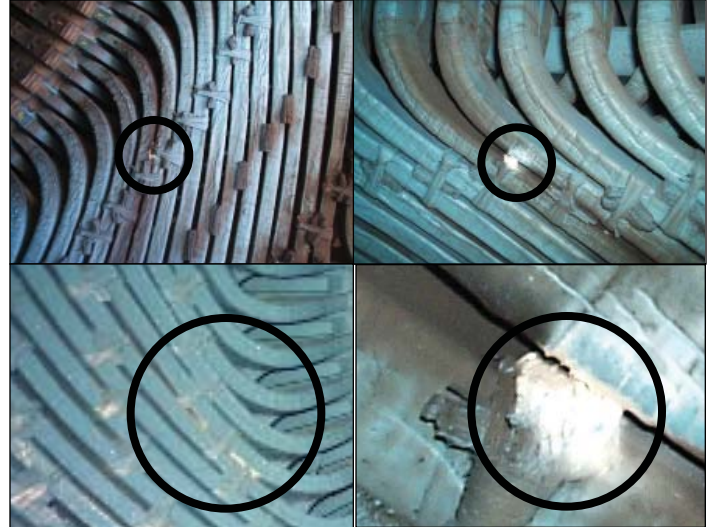
tor. Following pictures illustrate some typical cases of corona activity caused by inadequate spacing:

If there are two adjacent components from different phases with insufficient spacing between them, it is highly likely that corona activity will occur between the two. These components could be connection rings, end arms of different phases, etc. In air-cooled machines this corona activity leaves a white powder residue. This is a typical case of spark gap corona monitoring. Once a void is created on the surface of insulation, a potential difference builds across it and the discharges occurring across the void slowly erode the groundwall. Eventually a time may come when failure may take place. The closer the coils or components, shorter is the time to failure. The combination of inadequate spacing and a polluted operating environment can provide an ideal condition for corona discharge on the surface. Typically, nothing much can be done other than cleaning corona dusting and applying epoxy coating to minimize damage between two maintenance intervals. A permanent fix is redesign and rewind the genera-

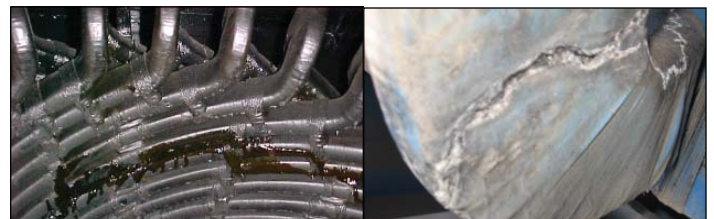
Any kind of conductive contamination from moisture or oil mixed with dust/dirt affects a machine as electrical tracking develops across the blocking or along the end arms. The electrical tracking occurs since a conductive path between two adjacent coils of different potential is created, and often from different phases. This is essentially a case of spark gap corona activity which occurs not because of mere design issues on the winding but winding contamination issues. This means once the contamination is removed, this corona activity will cease. As a result of the tracking, the groundwall insulation on the surface suffers deterioration. Left uncorrected, permanent phase-to-phase or phase-to-ground deterioration may occur and eventual failure of the groundwall is possible. Moisture condensation can take place both if machine has been sitting idle or it is operating in a high humidity inside the generator casing on account of moisture ingress from cooling system and or water contaminated oil system. The situation is remedied again by cleaning corona dusting and applying epoxy coating to minimize damage between two maintenance intervals and fixing moisture /oil contamination issues. Following pictures illustrate some typical cases of corona activity caused by contamination:

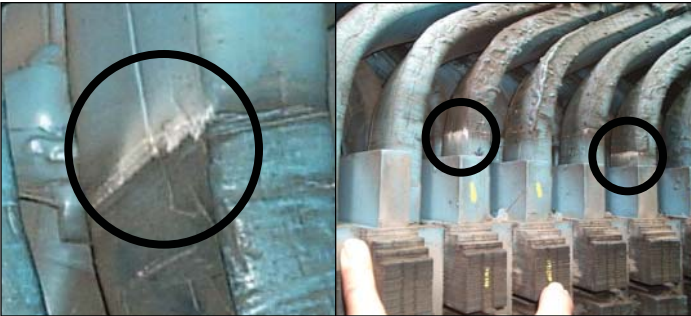
For adequate control of the voltage stress of a winding, the interface between the semi-conductive coating/tape and stress grading coating/tape materials must be effective (Figure) Due to high electric stresses, temperatures and environmental contamination, this interface may deteriorate over time especially with paints for voltage stress control. As a result of this deterioration, the stress grading coating loses ground contact, floats to a higher-voltage and sparks across the interface to ground. In air-cooled machines, this leaves white-band of residue at the slot exits. This corona dusting is readily seen while inspecting generators. Insulation damage from this type of deterioration is a slow process but given that this location is close to the slot exit, it is most susceptible to a ground fault on the generator left undetected and corrected. This corona activity is a kind of variable corona and spark gap corona usually seen at slot exit. Following pictures illustrate some typical cases of corona activity caused by deterioration of voltage stress interface:

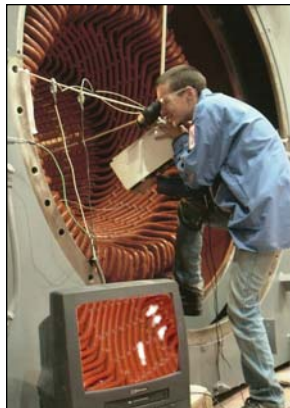
In order to perform a Corona Camera examination, the generator or electric motor must be dismantled to such a stage as to expose the stator end winding. At a minimum (assuming a horizontal machine) this would require the removal of the upper-outer end shield, and the upper and lower-inner end shields. Next, the stator windings must be energized with an AC power source. The power source must be substantial enough to energize each individual phase to full line-to-ground potential. For a winding name plated at 13,800 VAC, this would equate to approximately 8,000 VAC. Each individual phase of the windings should be inspected individually, with the

other two phases and all stator slot RTD's grounded. The Operator, or the Operator's assistant should have a marker attached to the end of an insulated stick. This apparatus is utilized in order to locate any/all points of concern with respect to corona activity. The Corona Camera itself should be connected to a video recorder. In this manner, the entire inspection is captured on tape. It is our recommendation a Corona Camera inspection be performed as a part of the initial or in-process examination of a winding, as well as part of the final acceptance process. A comparative analysis can be performed in order to verify that any/all corona activity of concern has been extinguished.

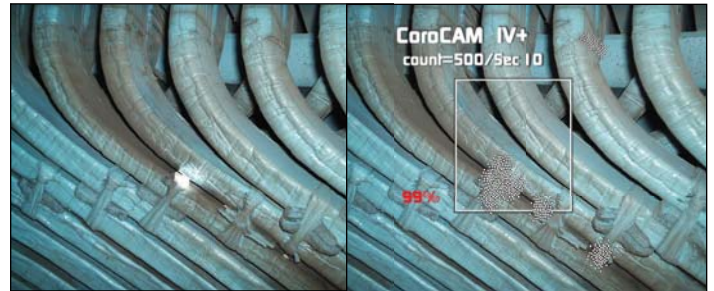
Unlike the standard "Lights-out" examination, where the energized windings must be covered in order to block out all external light, the Corona Camera inspection is performed under normal lighting conditions. As such, the Corona Camera inspection is significantly safer to the operators and observers. No more fumbling around in the dark, waiting for one's eyes to adjust, while standing next to an energized winding.
