Bonneville Power Administration Uses Daytime Corona Camera to Pinpoint Faulty Transmission Line Insulator

Success Story

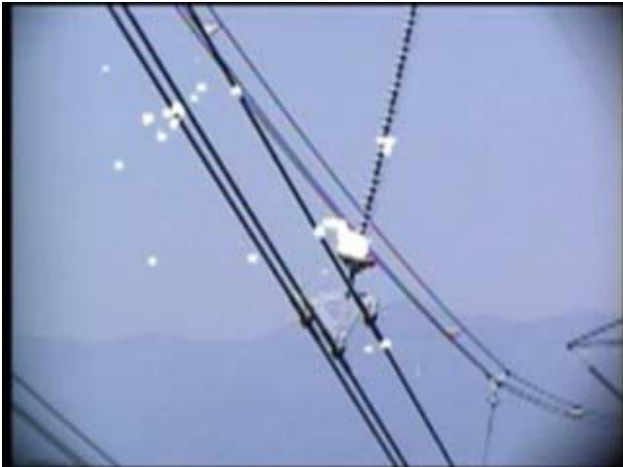
The EPRI daytime corona detection camera enabled Bonneville Power Administration staff to identify a damaged interphase spacer by detecting corona that was otherwise invisible to inspectors.

Using the daytime corona camera, BPA staff clearly saw corona and arcing activity at one of the interphase spacers. During a scheduled maintenance outage, a maintenance crew used a spacer cart to replace the component—which proved to be cracking and deteriorating.

Replacing the problem component during a scheduled maintenance outage helped avoid a costly failure that may have disrupted power system operations and customer service across a large portion of the Pacific Northwest.

Instead, removing the cracked component from service will allow BPA and EPRI to investigate degradation mechanisms and apply the lessons learned to future preventive maintenance efforts.
